Manhole Inspection Summary

Manhole # S21U__007MH

Location Address: **2101 washington bd**

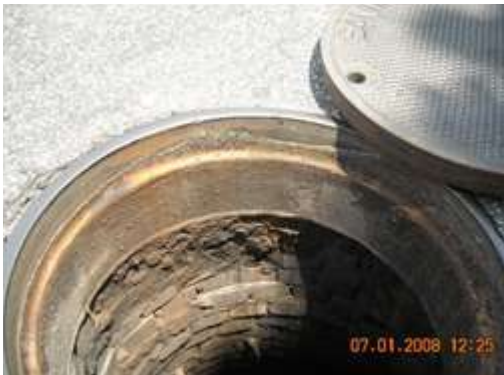
Subject To Ponding: **Sheeting**

inflow evidence from sheeting

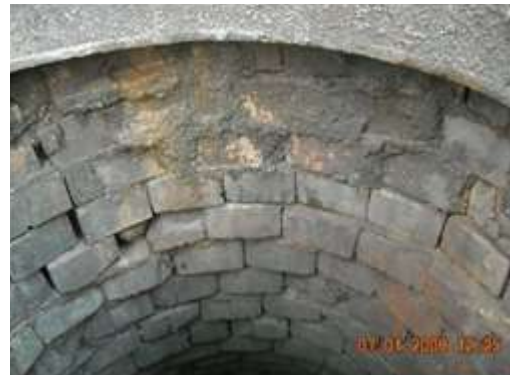
Defect 6

Infiltration: ☐ None ☒ **Joint** ☐ Cracks ☐ Mortar ☐ Roots ☐ Wall

Condition: ☐ Sound ☒ **Cracked** ☐ Root Intrusion ☒ **Loose Brick** ☐ Deteriorated

chimney infiltration, cracked corbel bricks, loose corbel bricks

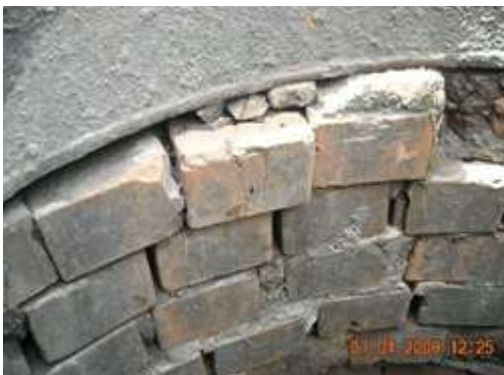
Defect 4

Condition: ☐ Sound ☒ **Cracked** ☐ Root Intrusion ☒ **Loose Brick** ☒ **Deteriorated**

cracked and deteriorating chimney, loose bricks in chimney

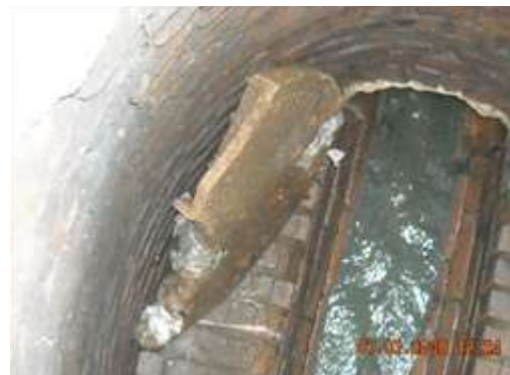
Defect 3

Condition: ☐ Sound ☐ Cracked ☐ Root Intrusion ☐ Deteriorated ☐ Leaks ☒ **Debris**

debris on bench

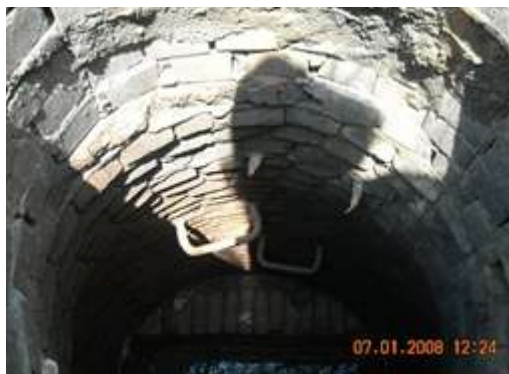
Defect 2

Steps Count: **2** Missing: **1** ☒ **Corroded**

corroded & missing steps

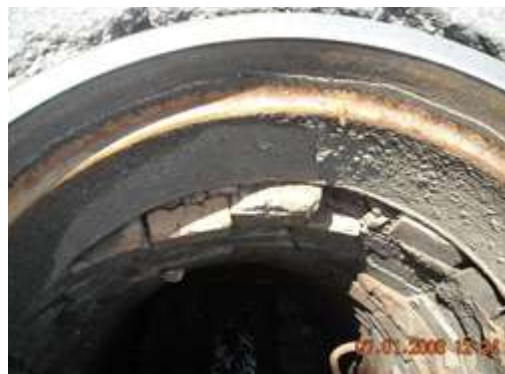
Defect 1

Frame Offset: **1** (in.) Condition: ☒ Sound ☐ Cracked ☐ Leaks

frame offset
